CHURCH OF THE HOLY SEPULCHRE JERUSALEM

STRUCTURAL SURVEY
FINAL REPORT

BY
WILLIAM HARVEY

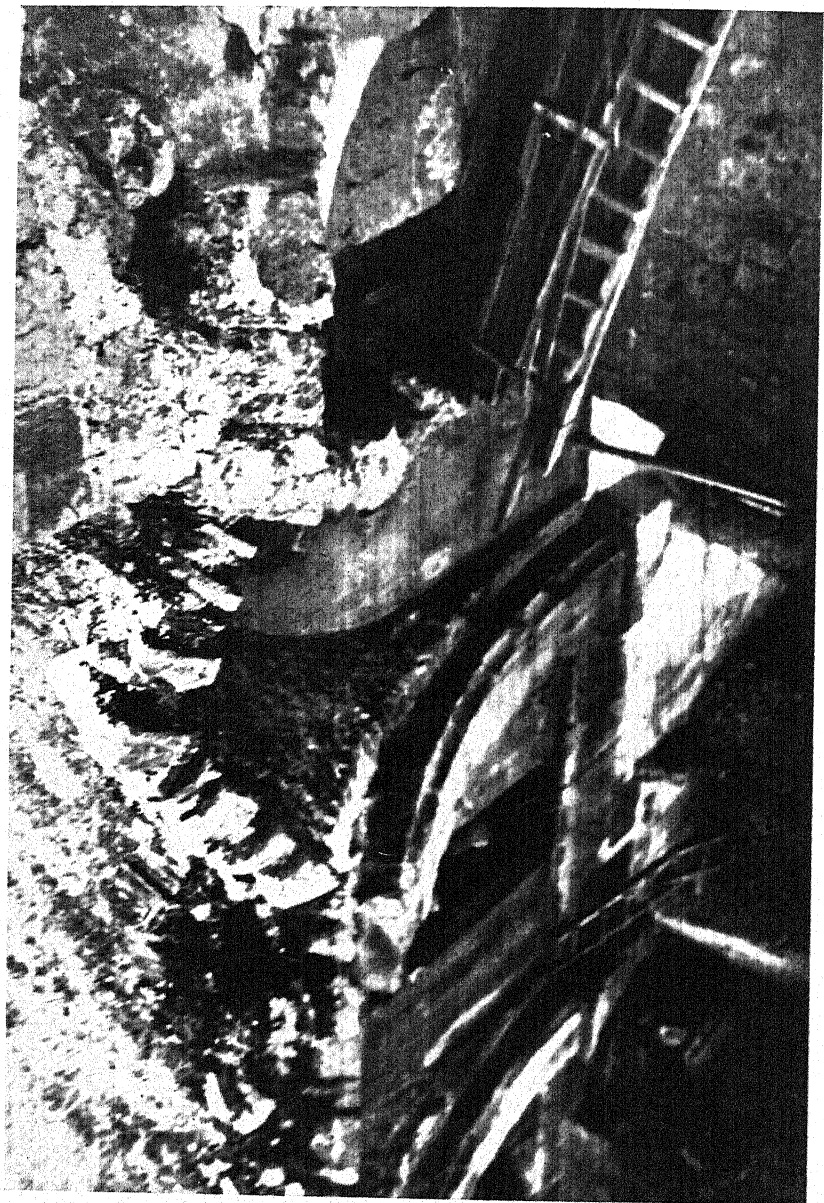
Secondly, the major part of the South wall of the old Latin Refectory (see Figs. 70, 71, II, 14) is in a ruined state, with large masses of overhanging vaulting. These are cracking away from the wall, and there is grave danger of their collapse.

FIG. 71. OVERHANGING VAULT MASSES OF OLD REFECTORY

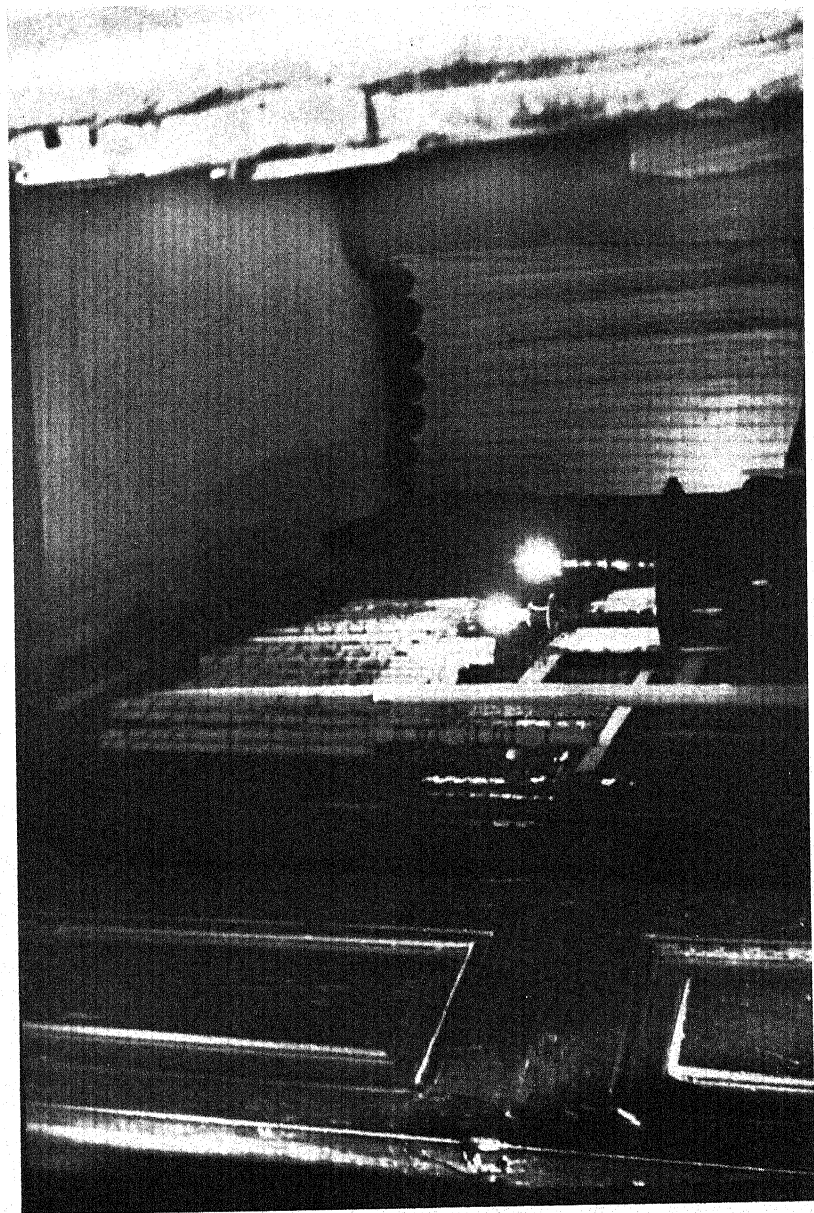
produce another such conflagration. Many of the small rooms which have been formed in the aisle of the Rotunda (see Figs. 72, I, 23) are used as stores for miscellaneous property, including large quantities of candles and oil. As there is much dry and decaying timber adjacent, a fire could easily be started, especially as only open lamps and candles are used for light in these rooms.

FIG. 72. CANDLE STORE IN OLD AISLE OF ROTUNDA

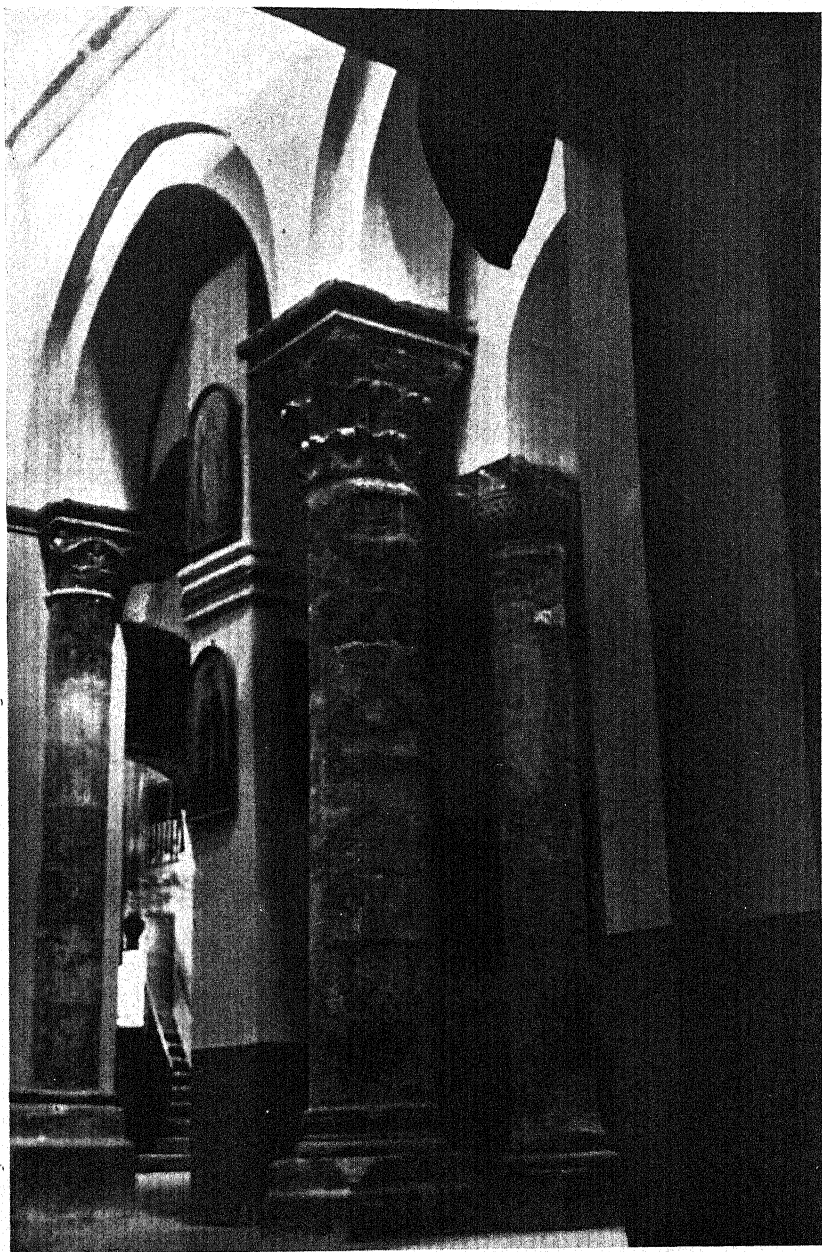
FIG. 73. PIERS OF NORTH TRANSEPT, SHOWING
MASONRY AND PLASTERED FACES

(1) An alteration which would affect the whole Church, though without changing the present arrangement, would be the stripping off of all plasterwork, thus revealing the original stone faces, which would then be carefully washed. As very large portions of the plasterwork would in any case be removed during the work of repair, this would involve little extra labour, and would greatly improve the appearance of the interior. Special care would have to be taken to ensure that any traces of original mosaic or colouring would be preserved (see Figs. 73, 74, 75).

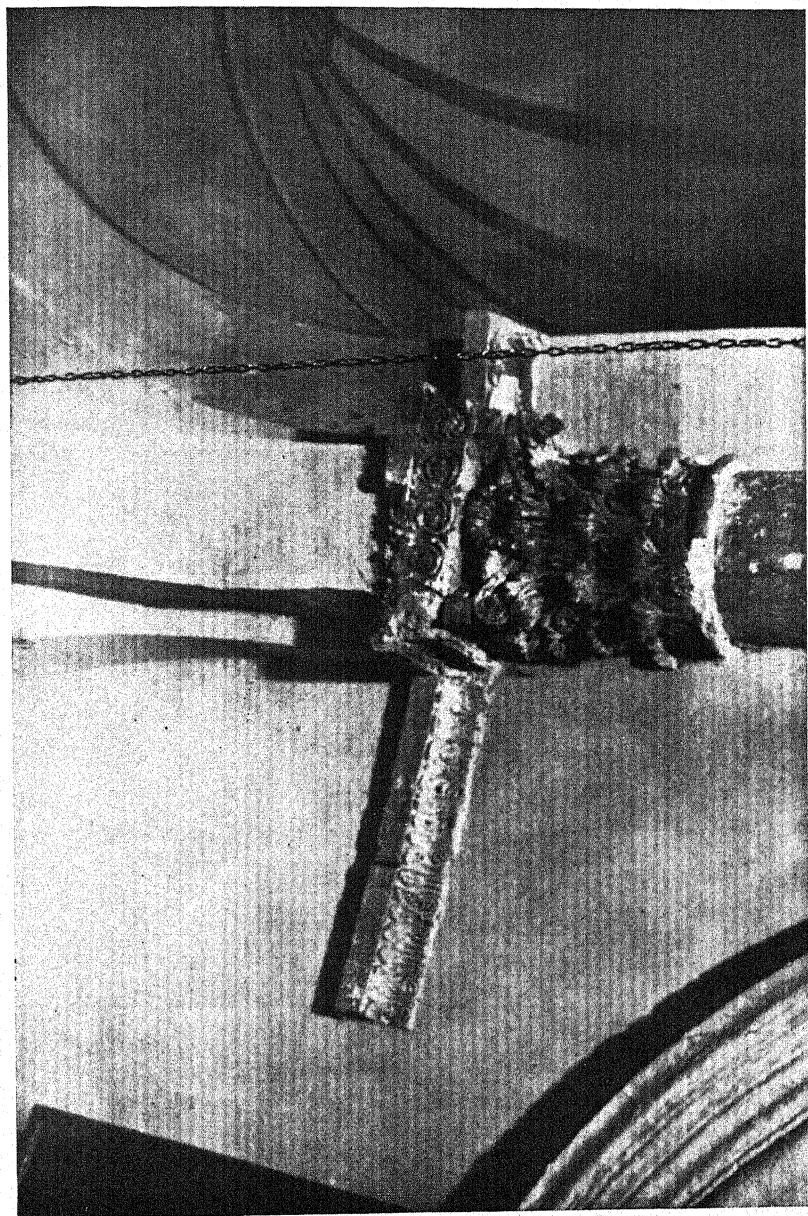
FIG. 75. CAPITAL IN AMBULATORY

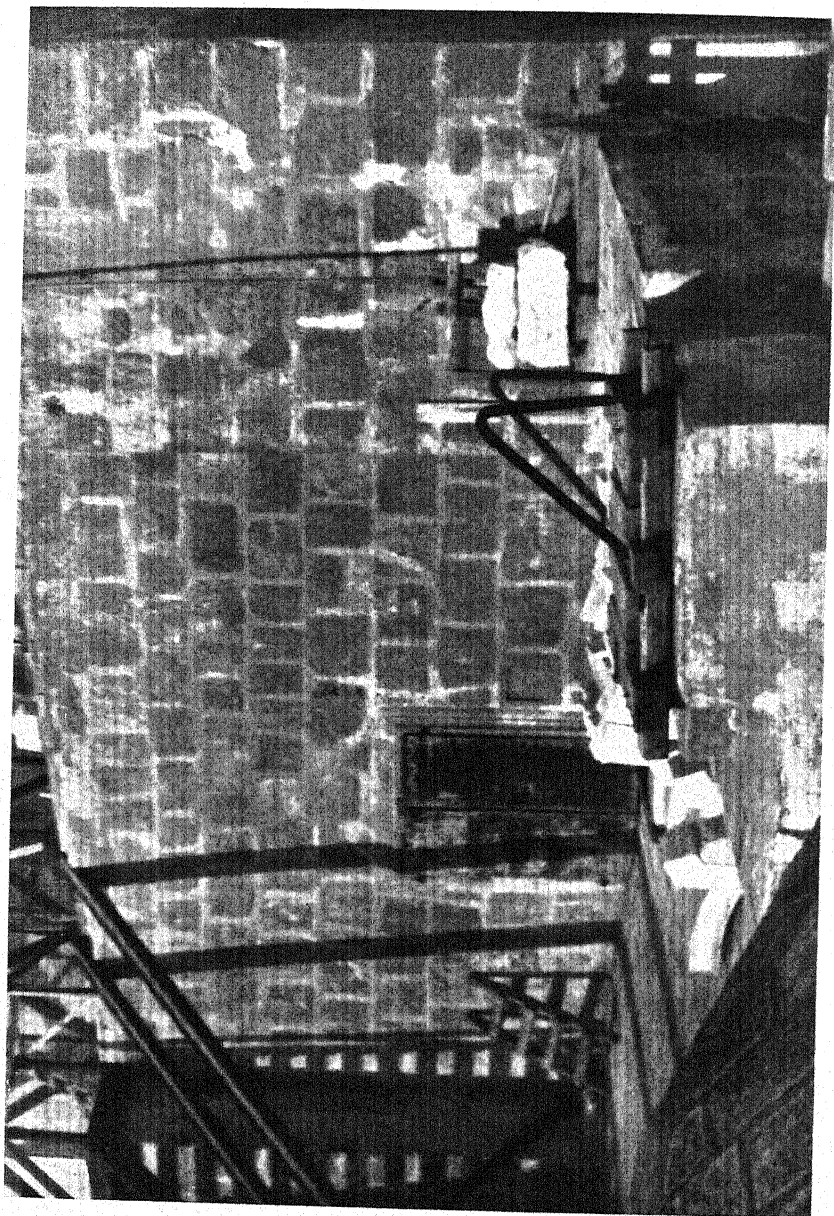
1. High vault North Transept West wall (1).
2. High vault East arm South wall (1) (see Fig. 76).
3. Ambulatory North-east apsidal chapel (2) (see Fig. 77).
4. Ambulatory centre apsidal chapel (3) (see Fig. 78).
5. Above stair to St. Helena's Chapel (1).
6. Ambulatory South-east apsidal chapel (2).

FIG. 76. WINDOW BLOCKED BY IRON DOORS

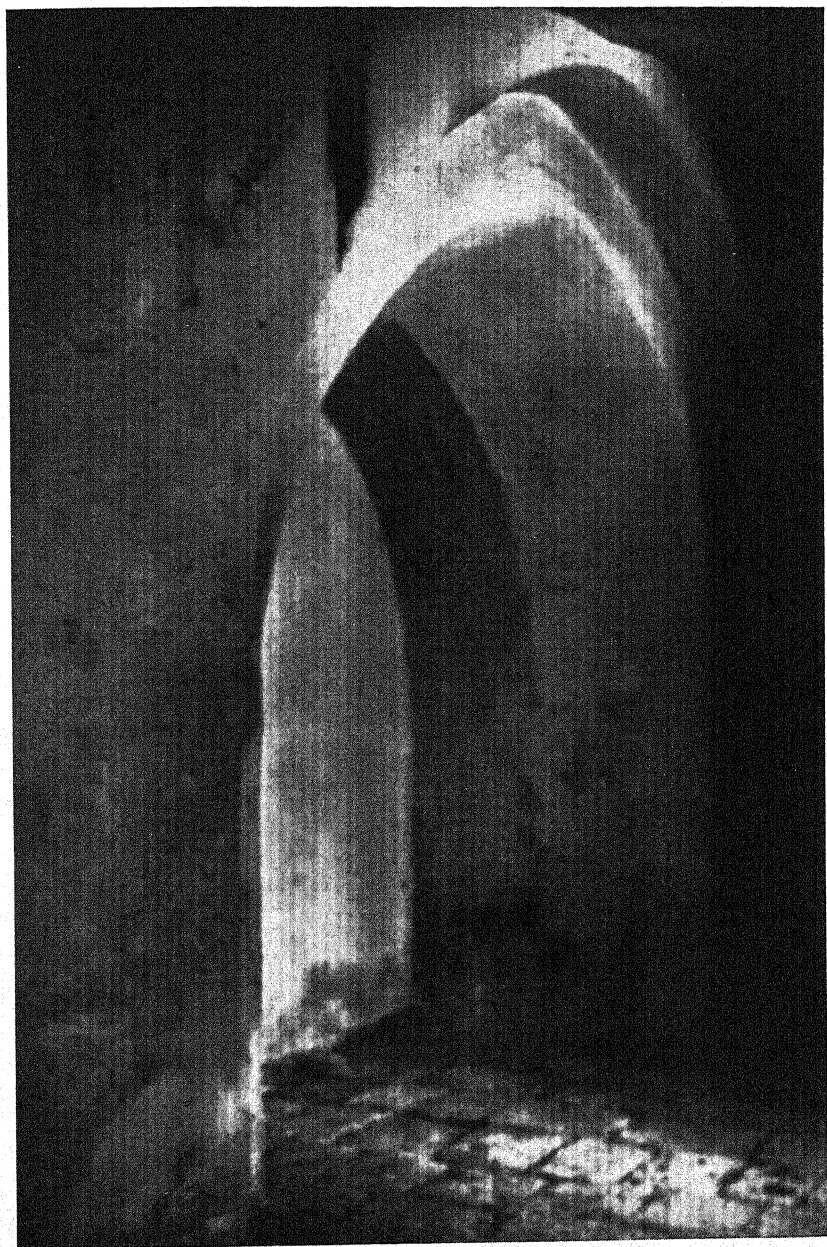
FIG. 77. BLOCKED WINDOW OF AMBULATORY

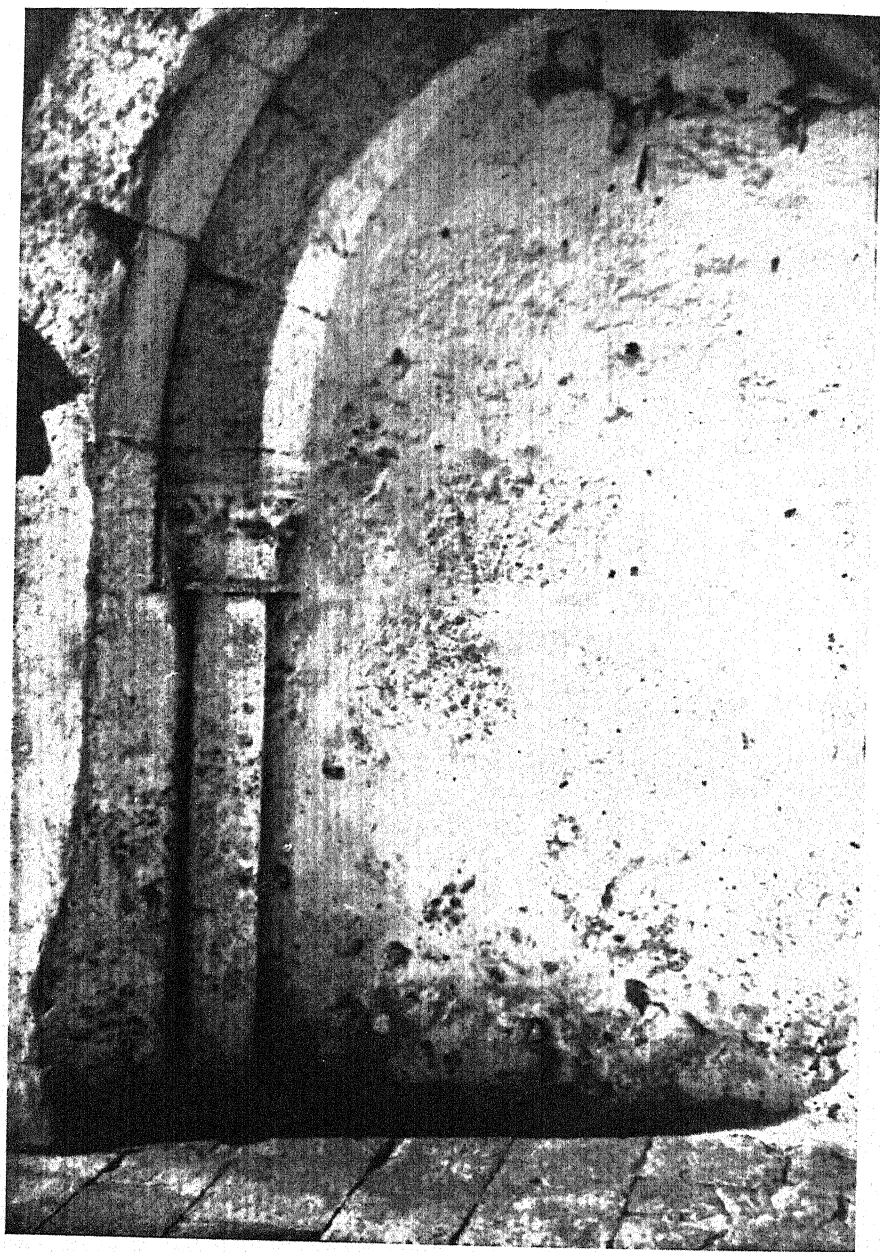
FIG. 78. BLOCKED WINDOW OF CENTRAL APSE CHAPEL

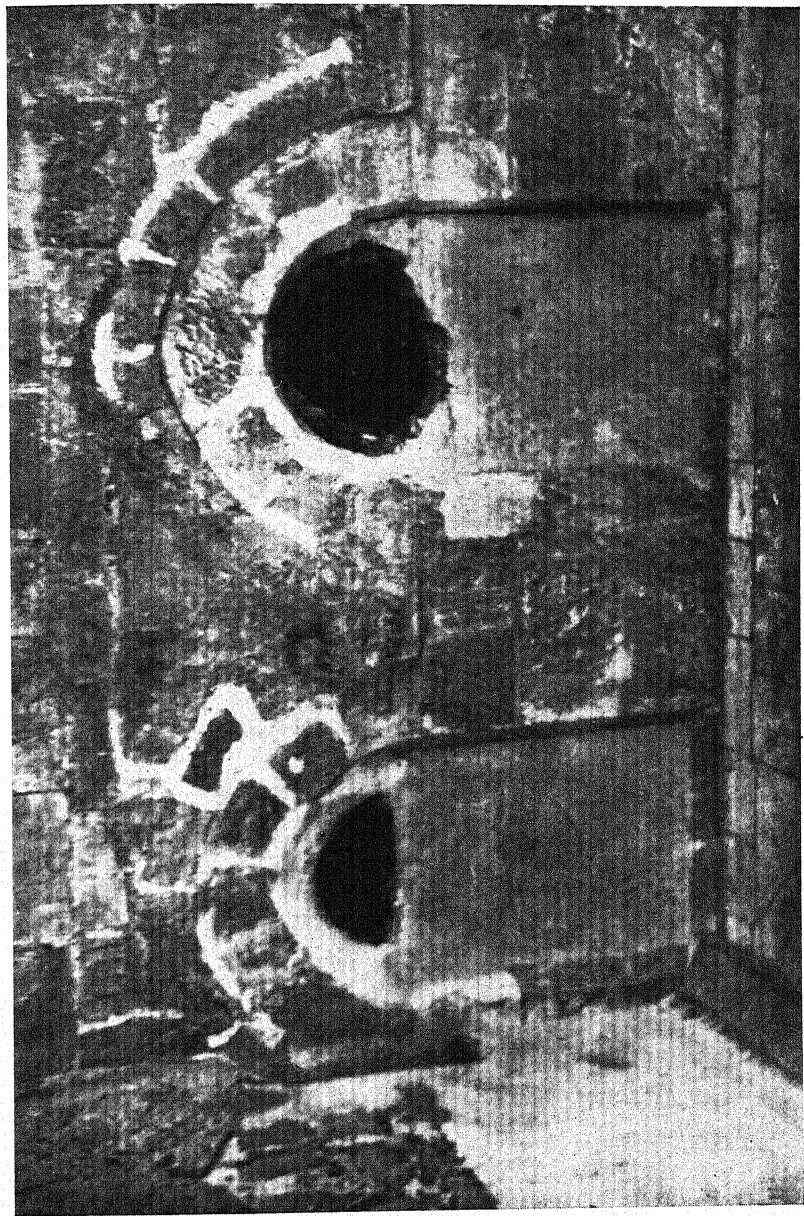
1. High vault North Transept North wall (2) (see Fig. 79).
2. High vault East arm North wall (1).
3. Eastern arm North wall—to Latin chamber (shuttered) (2).

FIG. 79. PARTIALLY BLOCKED WINDOWS OF NORTH TRANSEPT

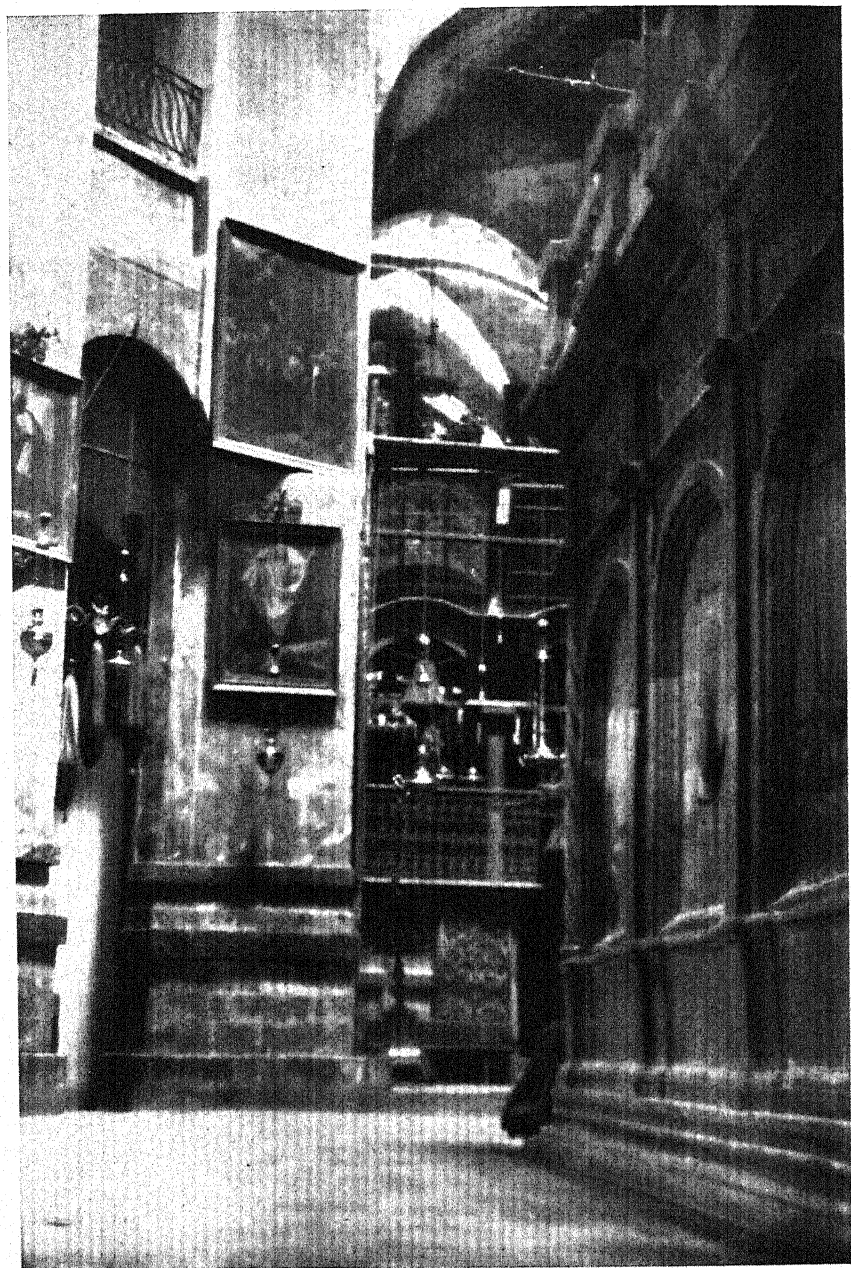
FIG. 87. NORTH ARCH OF KATHOLIKON

(3) The reduction in height of the present high walls of the Katholikon, between the main piers, to their original proportions, and the removal of the modern screen and railing at the West end of the Katholikon (see Figs. 87, 88).

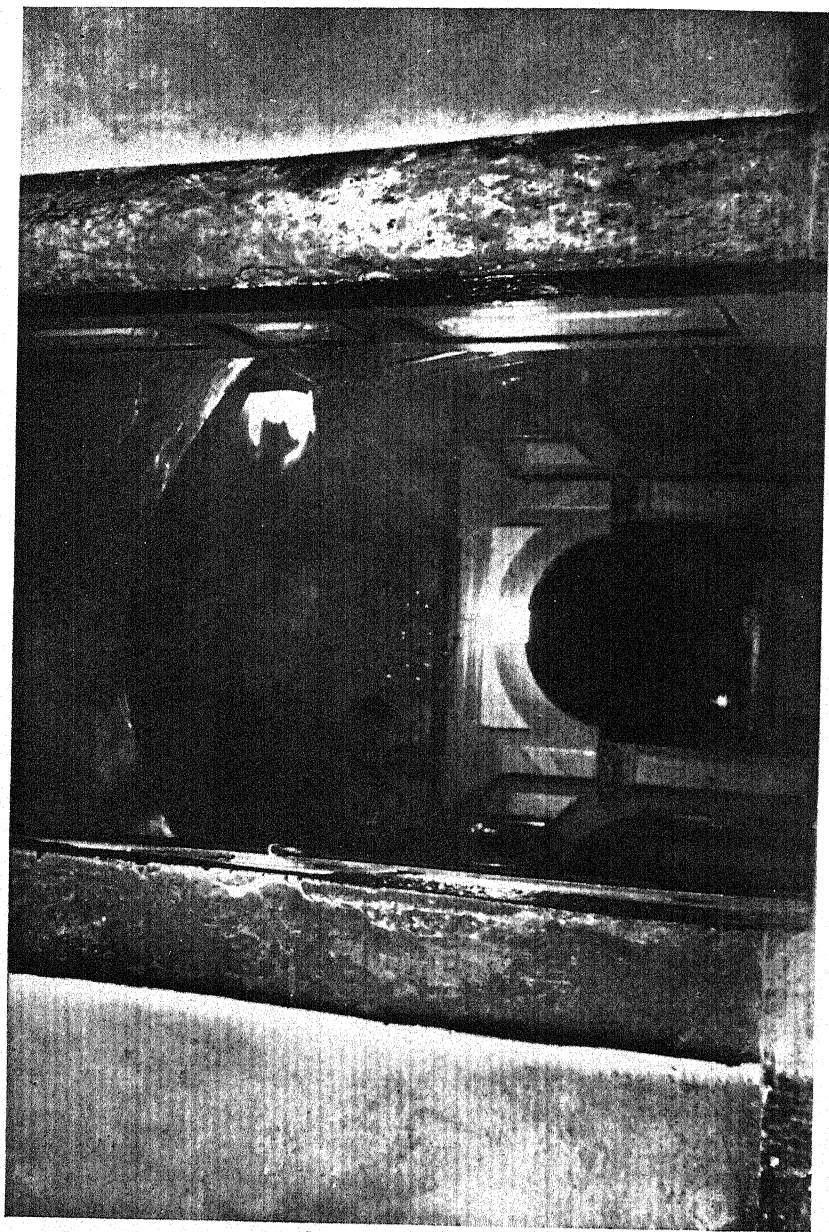
FIG. 89. SOUTH TRANSEPT EAST WALL

(5) Removal of modern vaults and partitions over the South aisle, connecting with the Calvary Chapels (see Fig. 89), and the reopening of the original stairs to Calvary from this aisle.

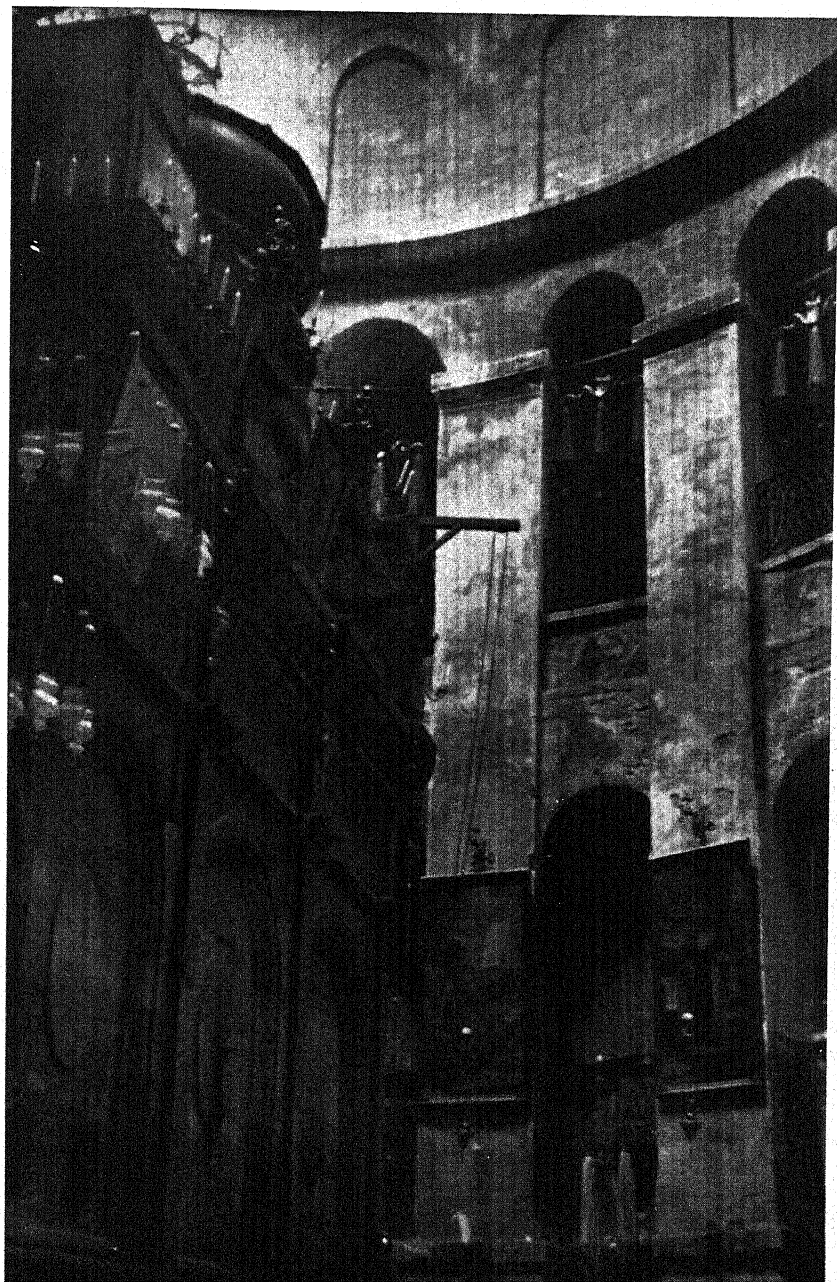
FIG. 90. CHAPEL OF ADAM

(6) Removal of modern work from the Chapel of Adam beneath Calvary (see Figs. 90, I, 11).

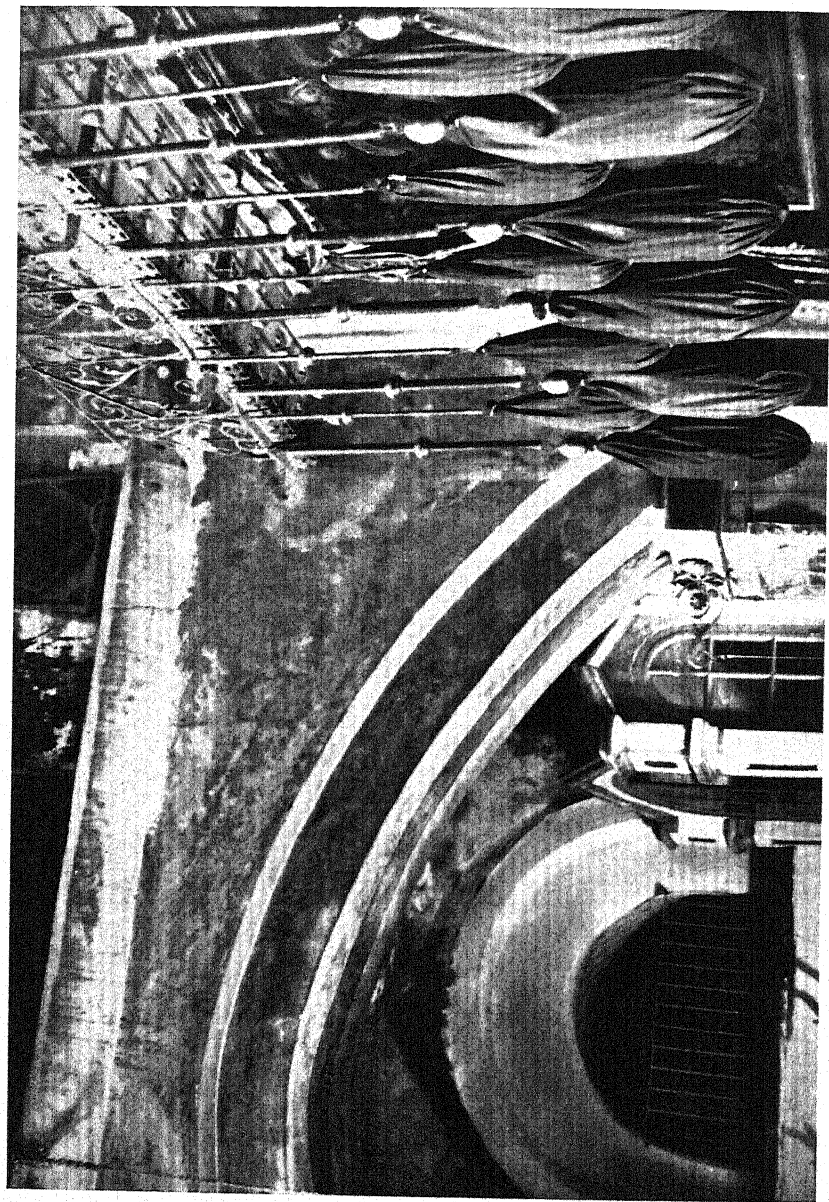
FIG. 91. ROTUNDA PIERS

(7) Removal of all modern partitions, stairs, &c., in outer aisle of Rotunda, and reopening of it as a complete passage surrounding the Sepulchre (see Figs. 91, I, 15, 23).

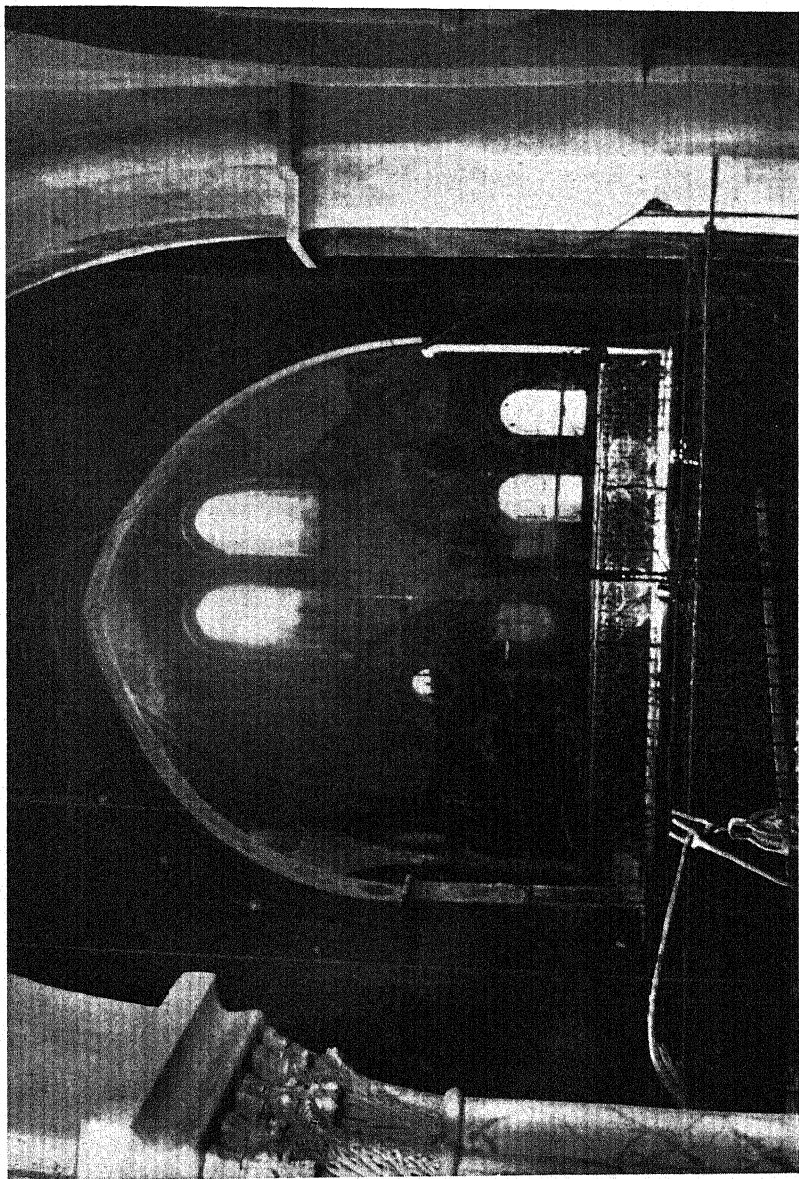
FIG. 92. SOUTH TRANSEPT, WEST ARCH

Rotunda and Armenian Sacristy from South Transept (see Fig. 92).

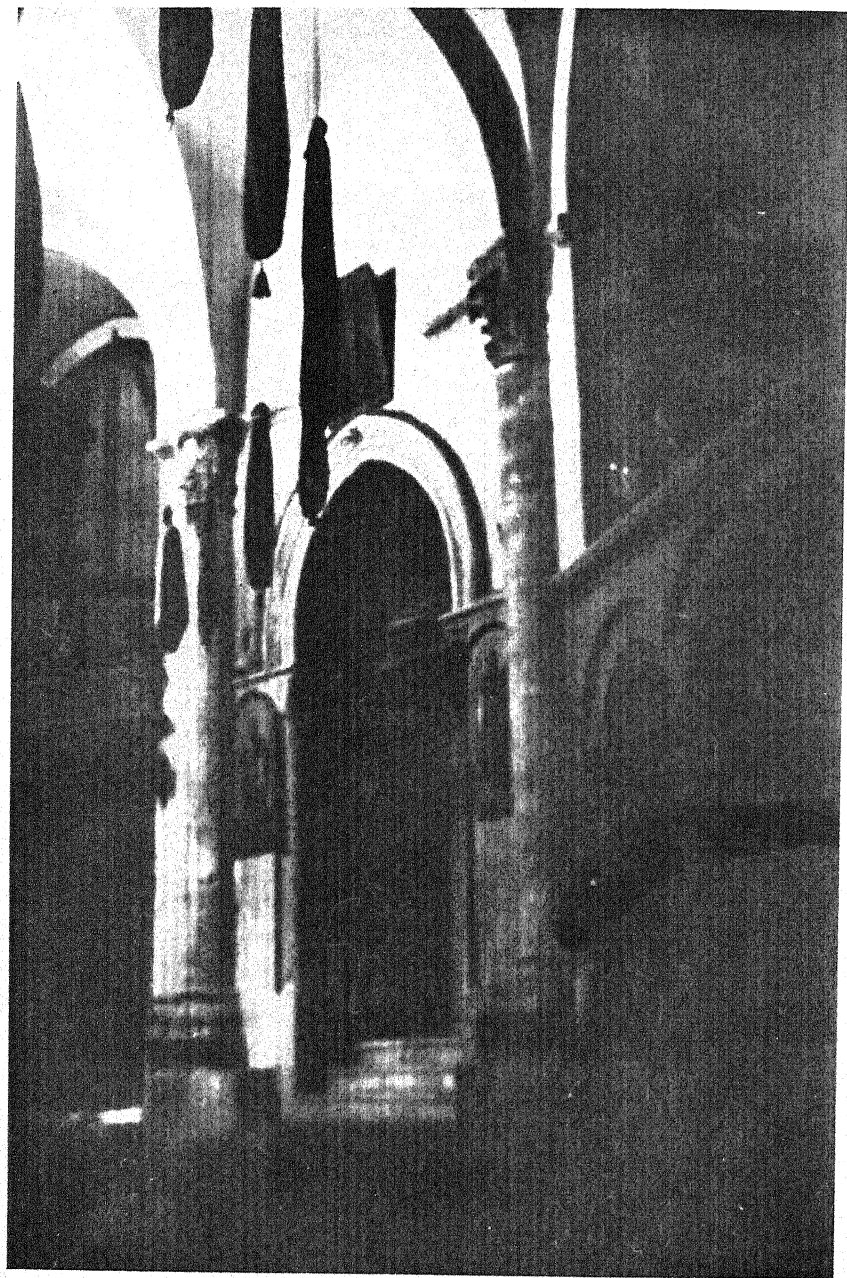
FIG. 93. SOUTH TRANSEPT FROM NORTH TRANSEPT

(9) Removal of partitions and cupboards preventing free lighting of the South Transept, through the Armenian gallery (see Figs. 93, II, 4).

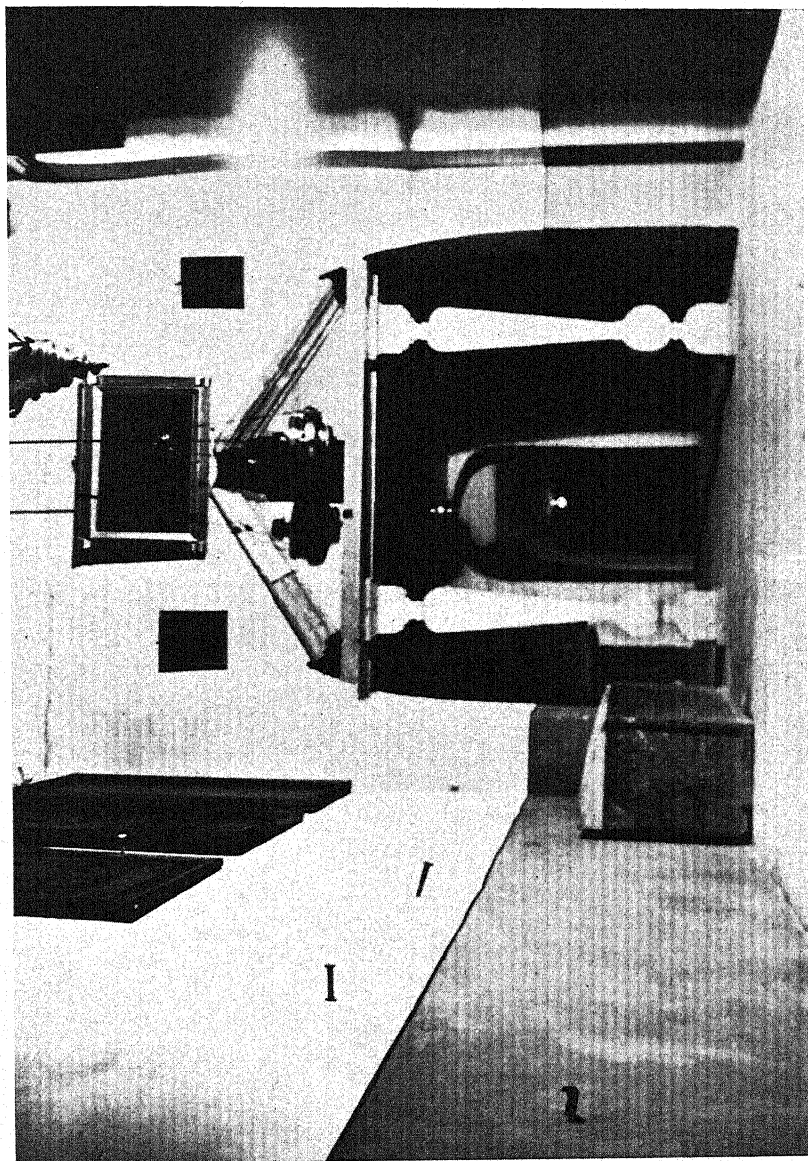
FIG. 94. AMBULATORY

(11) The reopening of the old door in the north-east of the ambulatory, as an access to the Coptic Convent, the Ninth Station, and the lane beyond (see Figs. 94, I, 30).

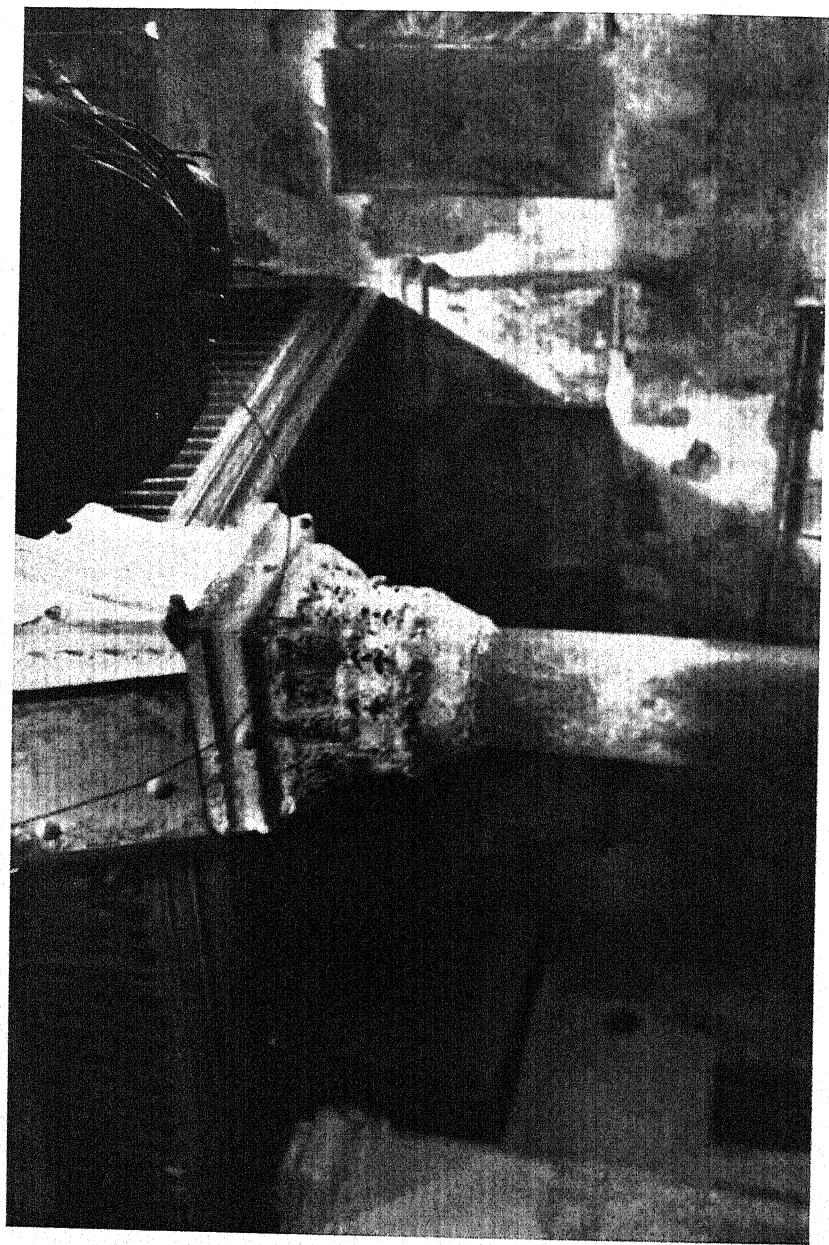
FIG. 95. PORTAL OF 1810 TO CHAPEL OF BONDS

(12) Removal of pillars and pediment built in 1810 from archway leading to the Chapel of the Bonds (see Figs. 95, I, 17).

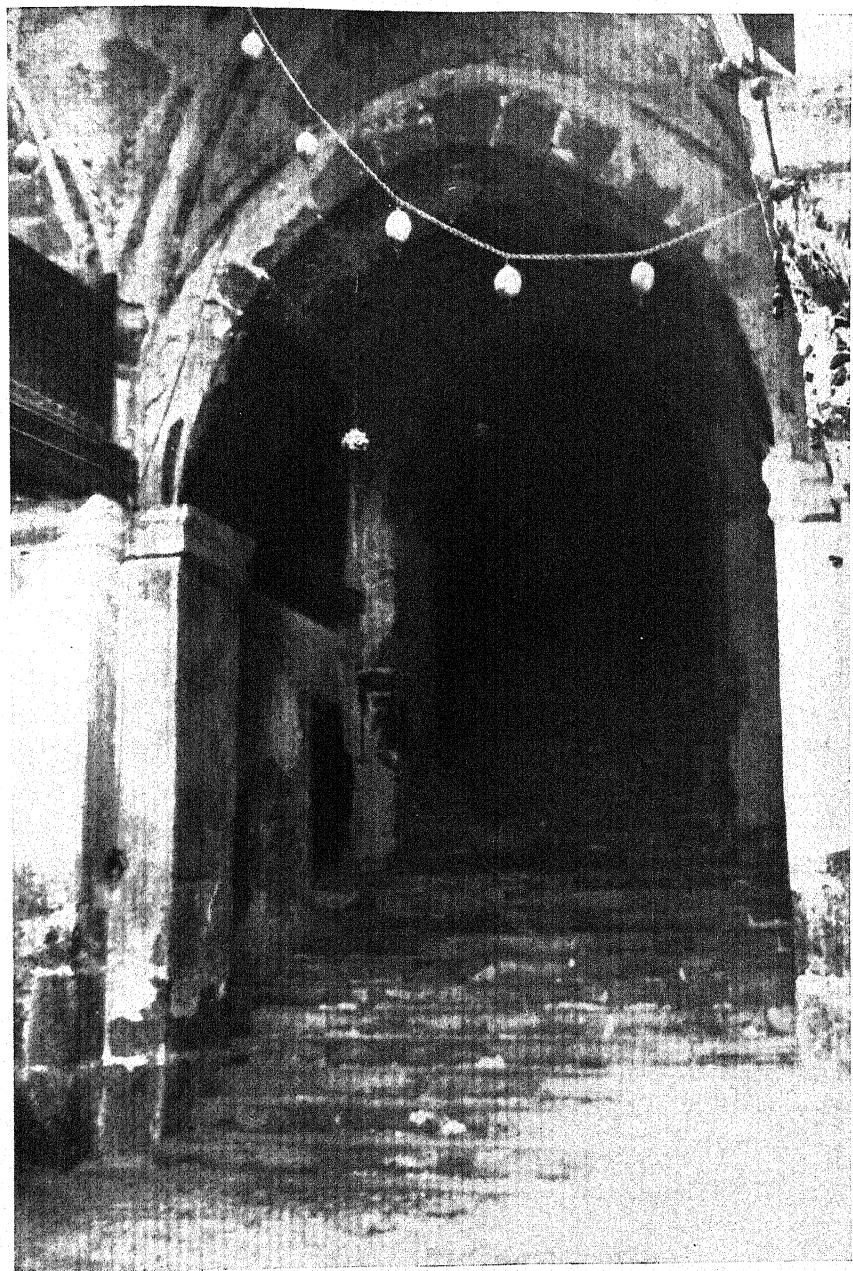
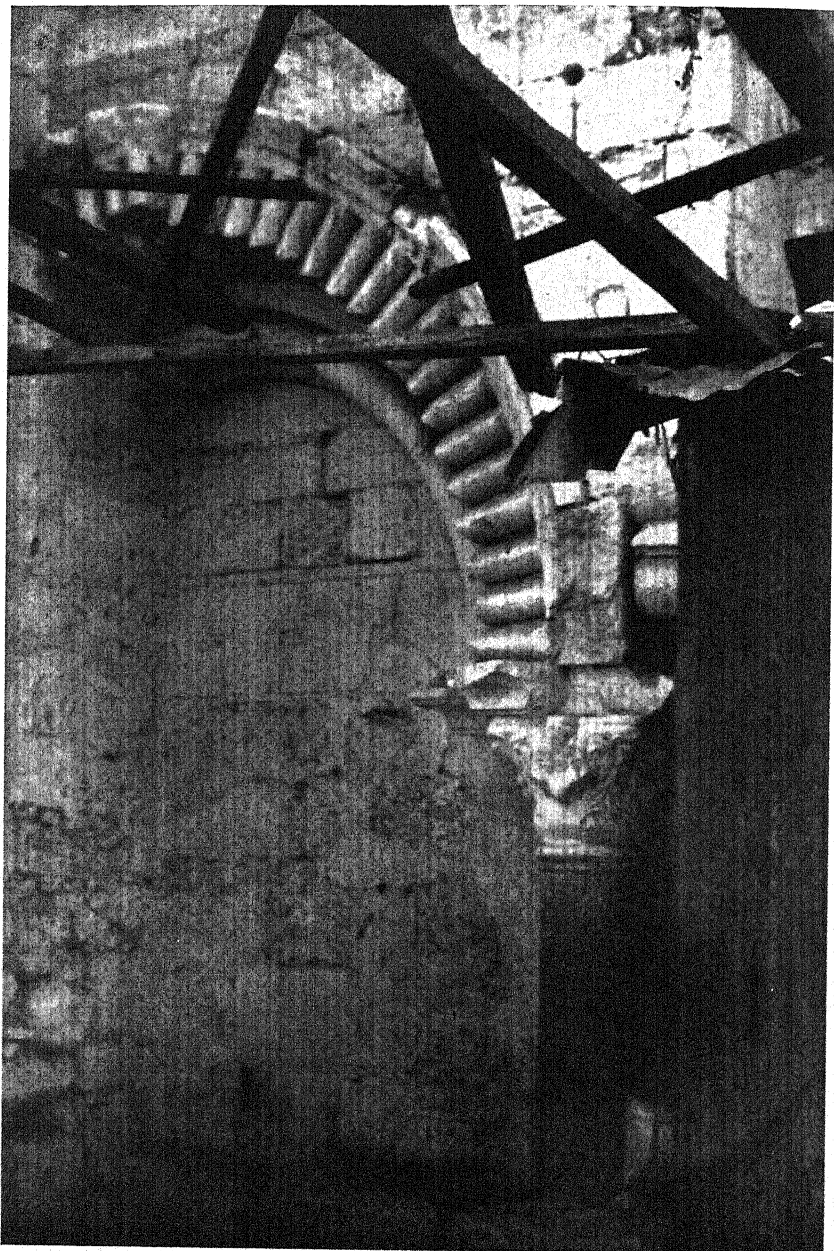
(13) Removal of the present partitions and wooden galleries from the western bays of the Chapel of St. Helena (see Figs. 96, 97, I, 28).

FIG. 96 ST. HELENA'S CHAPEL. NORTH-WEST BAY

FIG. 97. STAIRS FROM ST. HELENA'S CHAPEL

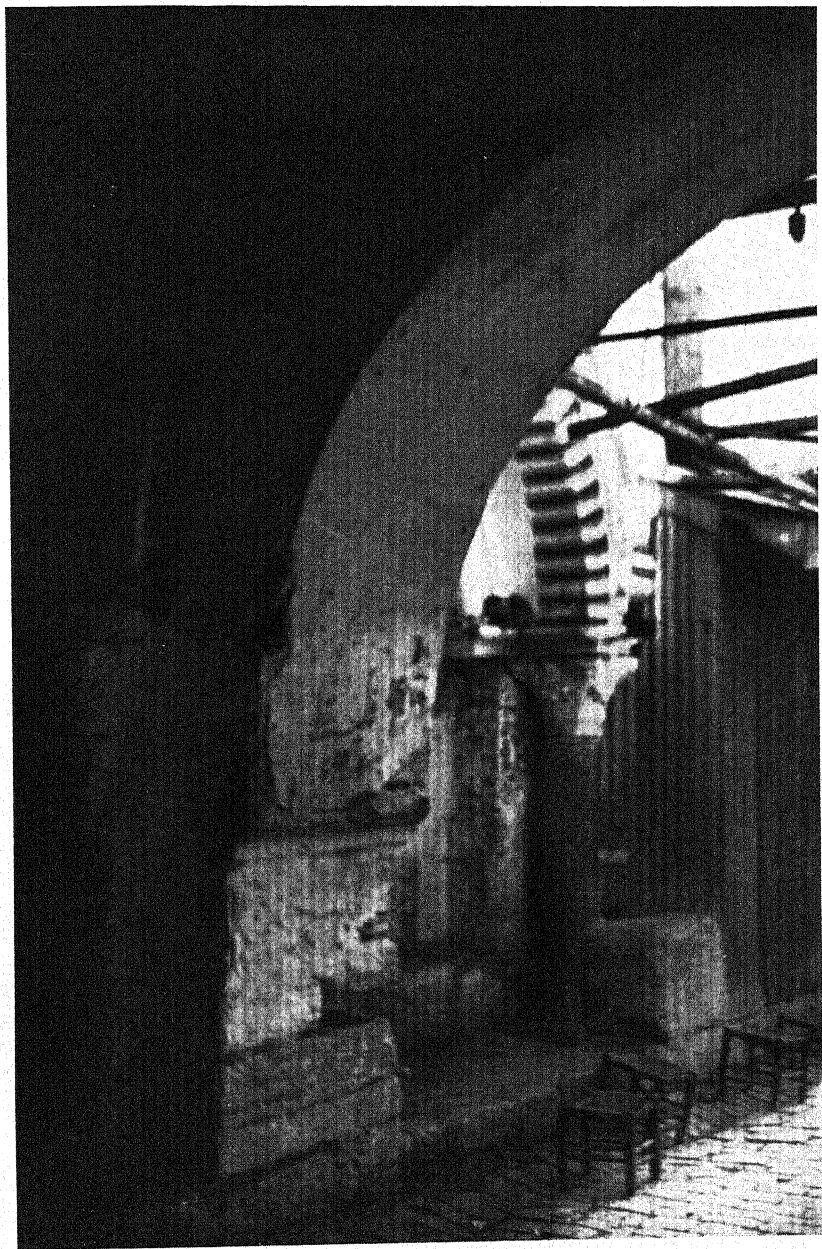
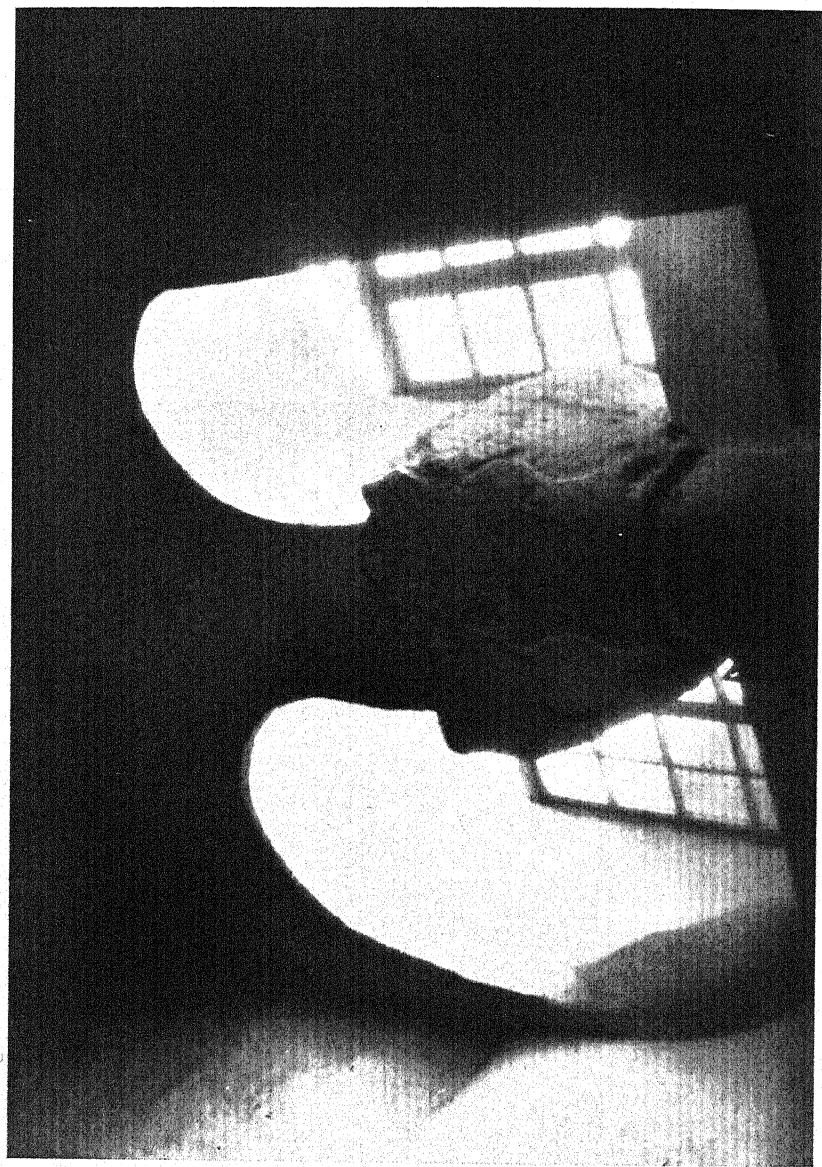
(14) Reopening of original St. Mary's Door in Christian Street, as an entrance to the Church, communicating with the passage to the North apse of the Rotunda. This would necessitate certain alterations in the piers supporting the vault over Christian Street (see Figs. 98, 99, I, 22).

FIG. 98. ST. MARY'S GATE, CHRISTIAN STREET

FIG. 99. ST. MARY'S GATE

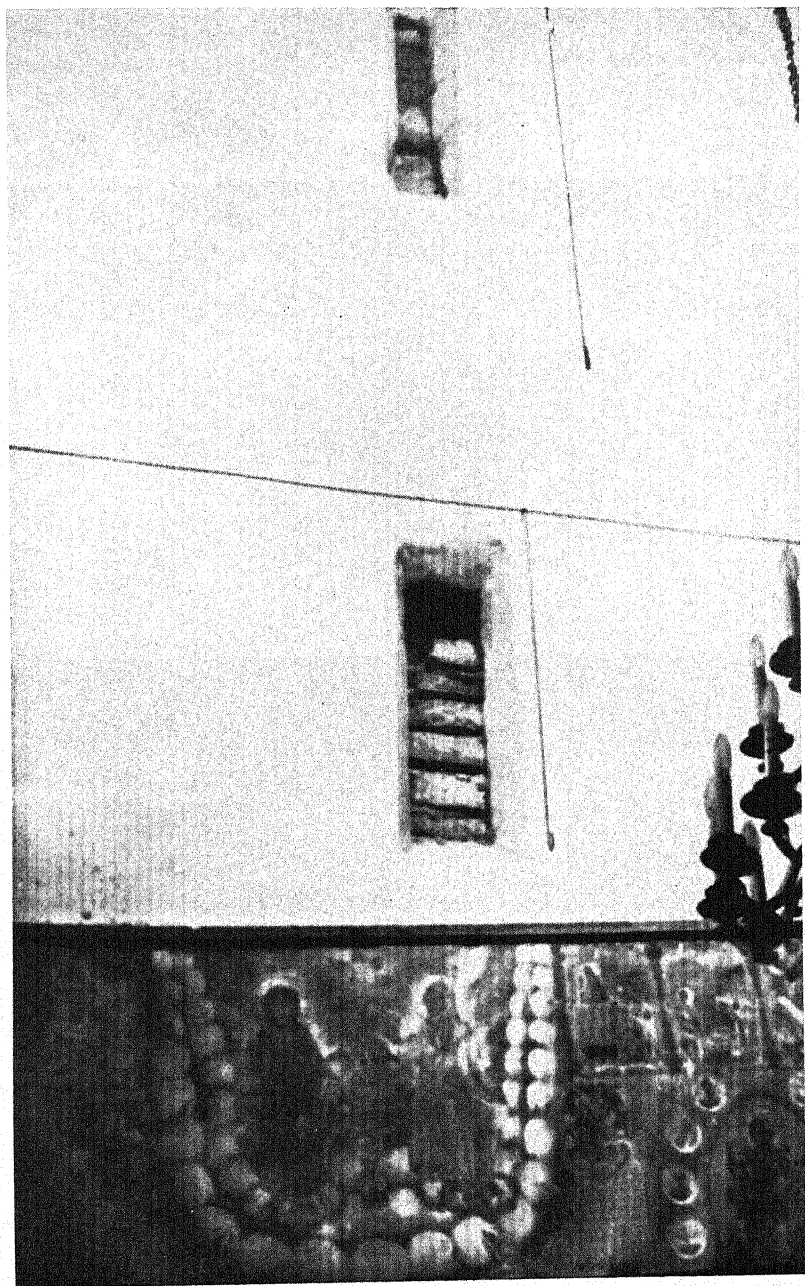
FIG. 100. BYZANTINE ARCADE IN LATIN REFECTORY

(15) Alteration of the present Latin Refectory to allow of opening of Byzantine arcade now enclosed in its western wall (see Figs. 100, I, 20).
